Dest Report Residential Jire test

Intertek Testing Services NA, Inc.

Subject: ITS Letter Report No. J20022860-231

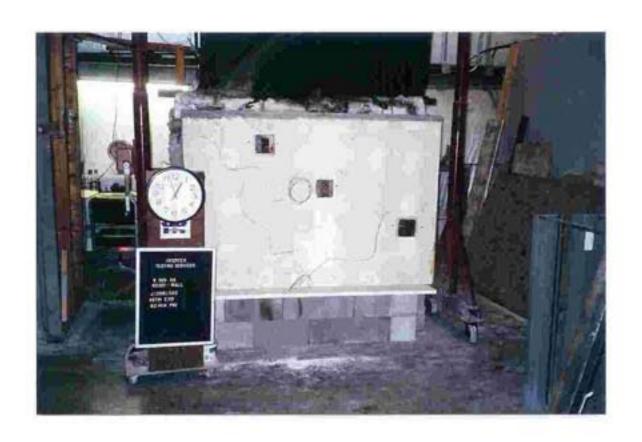
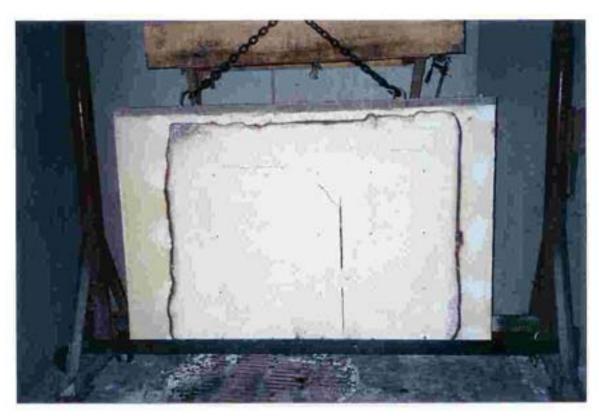
FIRE ENDURANCE

TIME	EXPOSED FACE
(min:sec) 00:00	Furnace ignited.
03:44	Gypsum panel paper ignited.
24:30	Joint compound starting to peel off of the drywall joint.
26:00	Drywall starting to crack horizontally at the upper and lower right hand side.
32:30	Horizontal crack on the upper left side. Other cracks now approximately 1/16" wide. Vertical drywall joint exposed.
45:00	Drywall joint expanded to 3/16", but no flaming from it. No change in size of horizontal cracks.
50:00	Flaming from bottom of drywall joint.
56:00	Steady flaming extending along the bottom of the wall.
60:00	Test stopped.
TIME	UNEXPOSED FACE
(min:sec)	
00:00	Ambient temperature = 59 °F.
30:00	No change.
60:00	Test stopped.

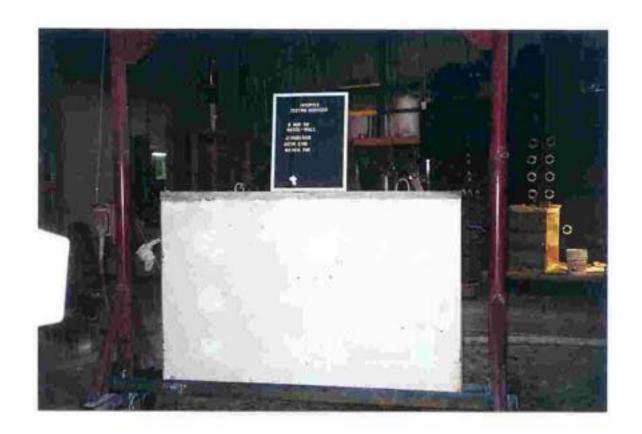
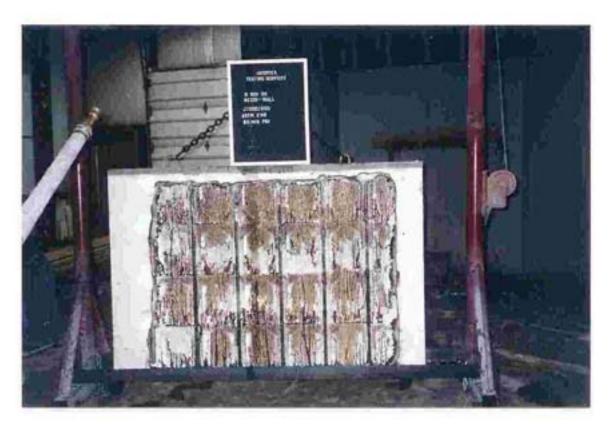
AFTER HOSE STREAM TEST

A Hose Stream Test was conducted for 15 seconds at 30 psi. Test assembly passed hose stream test with no through opening and allowable movement limits.
